Loss of Electrical System over the Rocky Mountains: And that was the Good News!

17 January, 2024
VASI Meeting, Venice, FL

Jack Henion

Engine and Equipment Status for N5379A

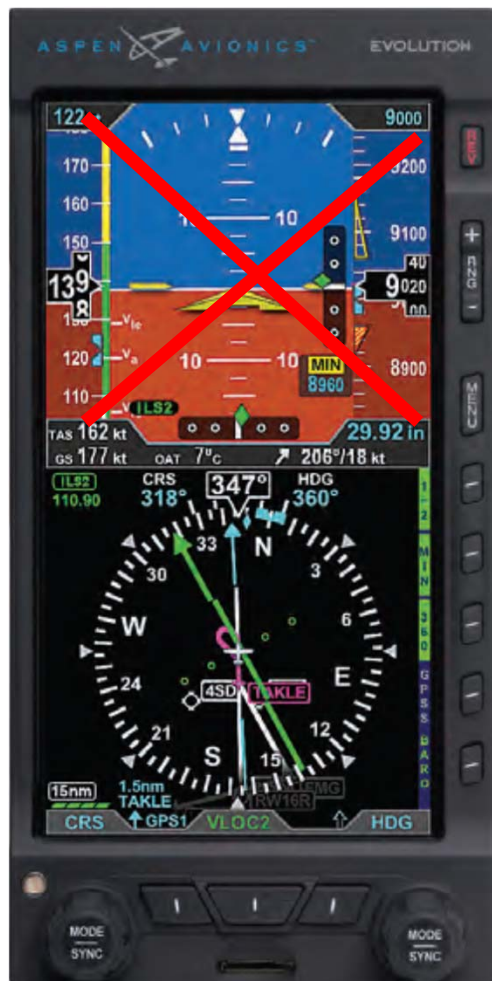
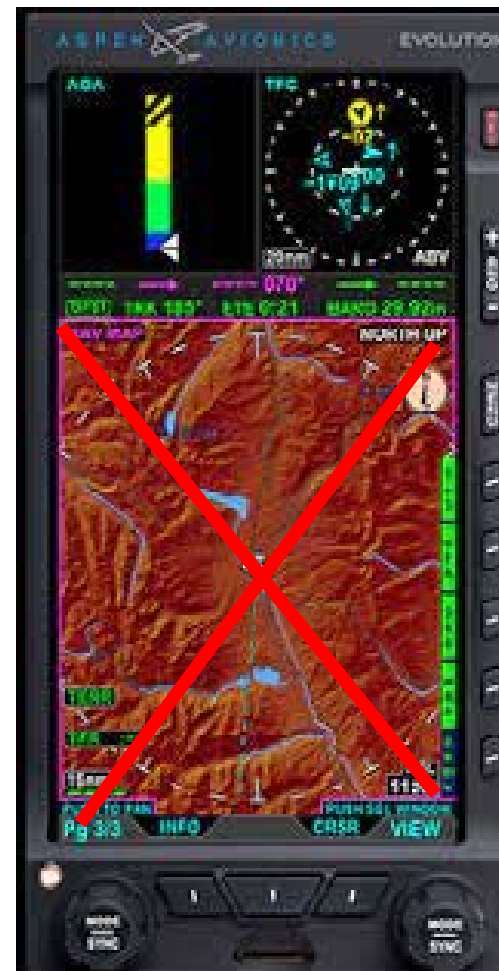
After reaching 12,000 ft I suddenly saw this and major discharge on the JPI 930 EDM alternator meter

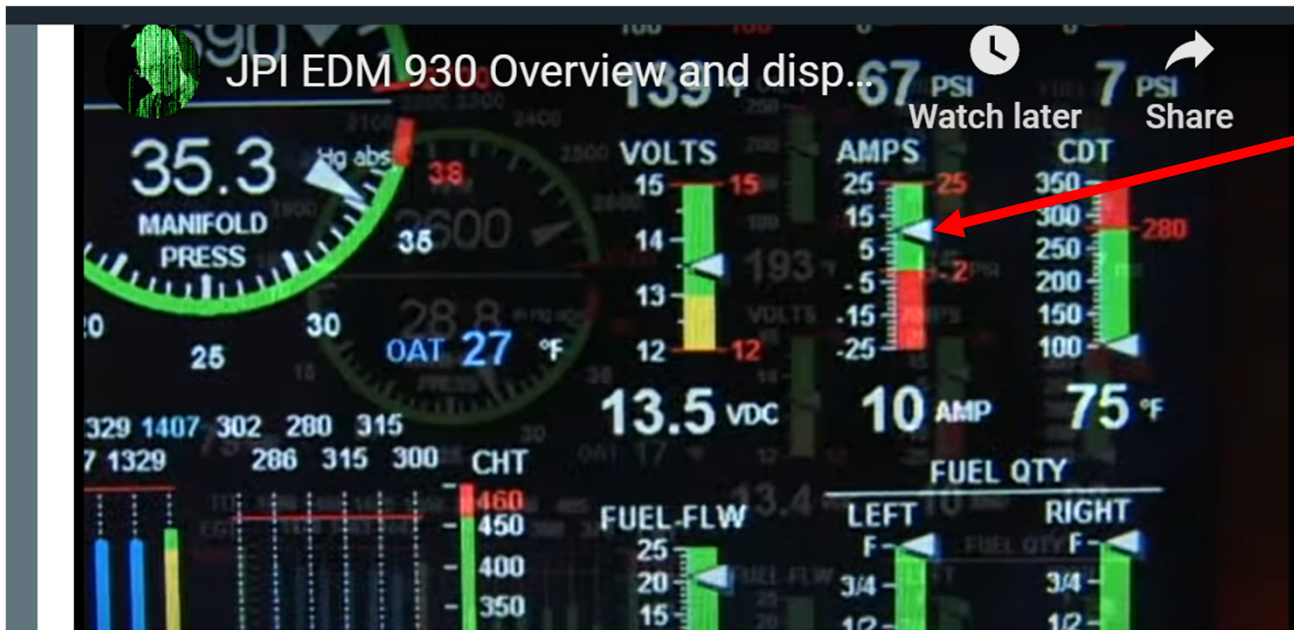
JPI 930 EDM immediately showed alternator failure

This arrow dropped into the red!

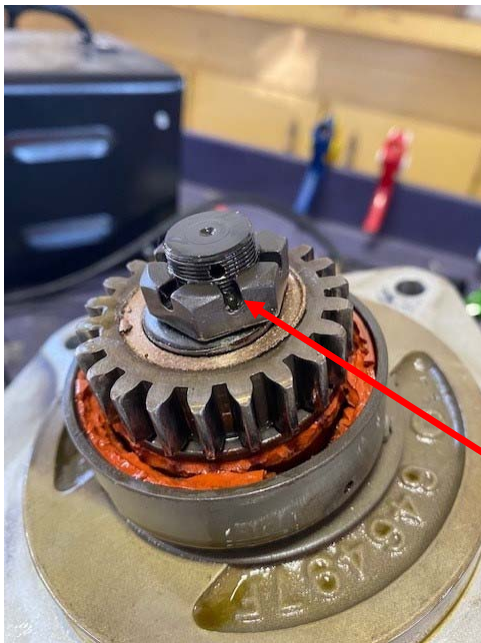
Noticed the Alternator Drive Gear was missing its Cotter pin and was Loose!

No Cotter Pin

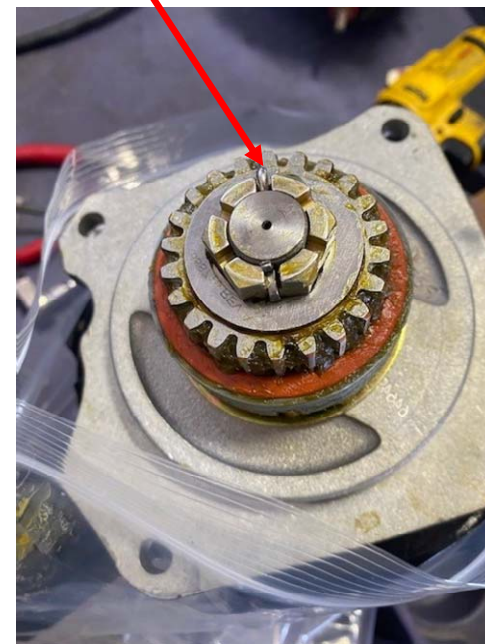
What it should look like with with Cotter Pin in Place

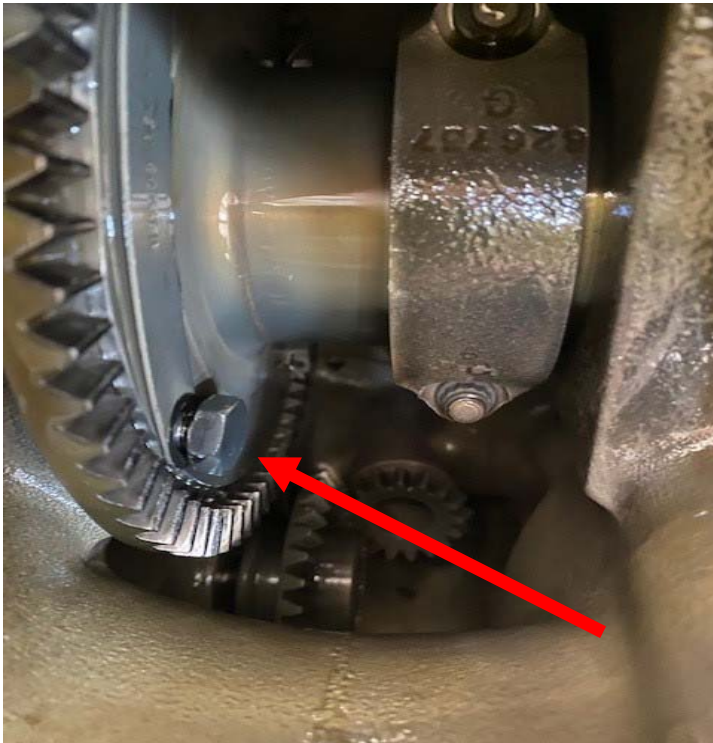
Four Loose bolts on Crankshaft Face Gear!

Loose Bolts

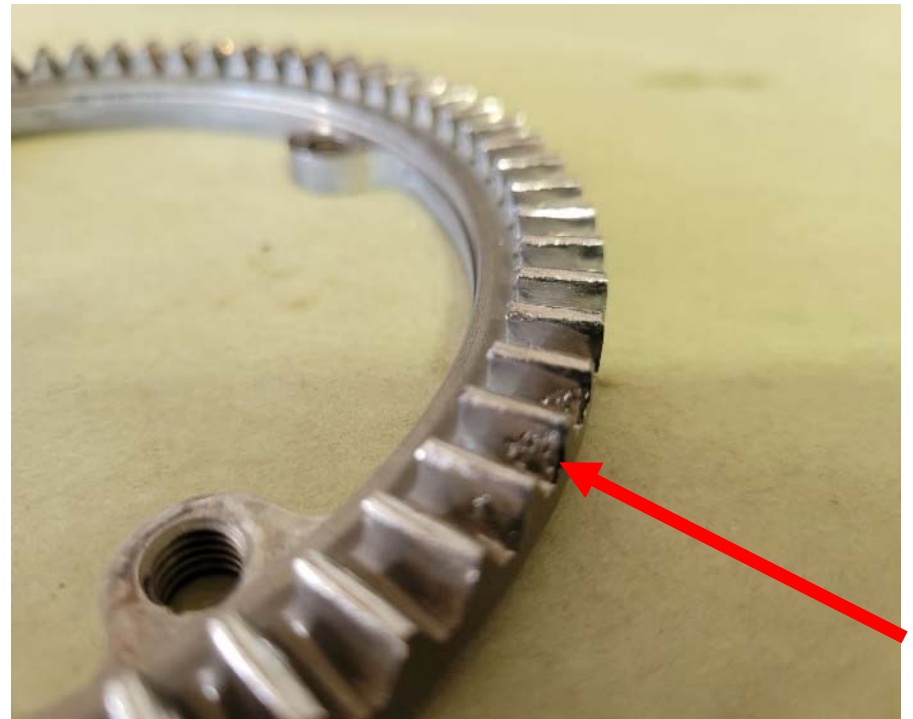
Damage to Face Gear Teeth

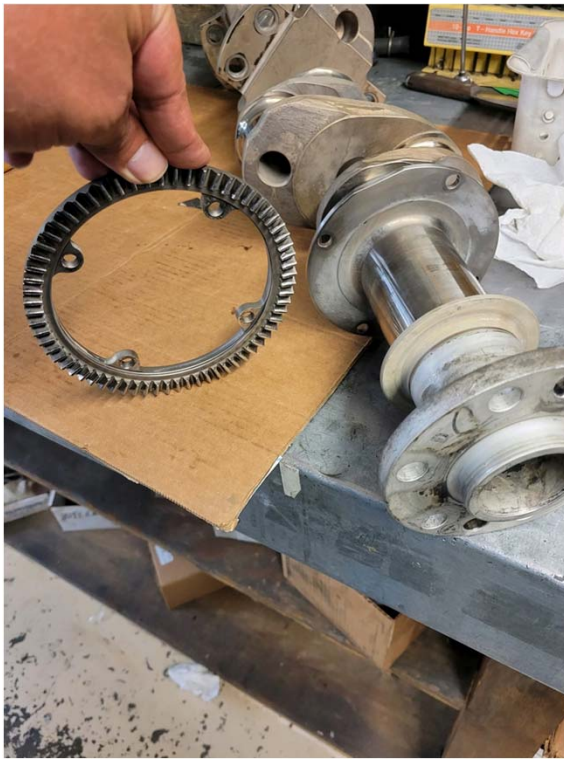
Damaged Face Gear Removed from Crankshaft

Face Gear Removed from Crankshaft

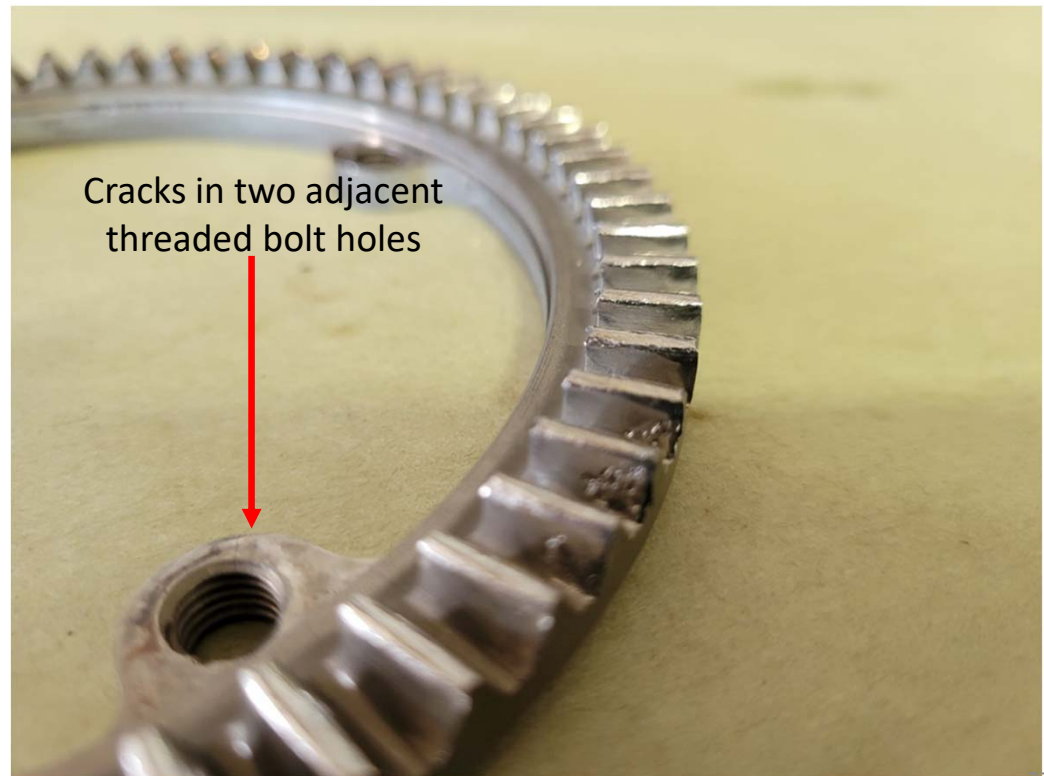
Crack in two of the Threaded Bolt Holes

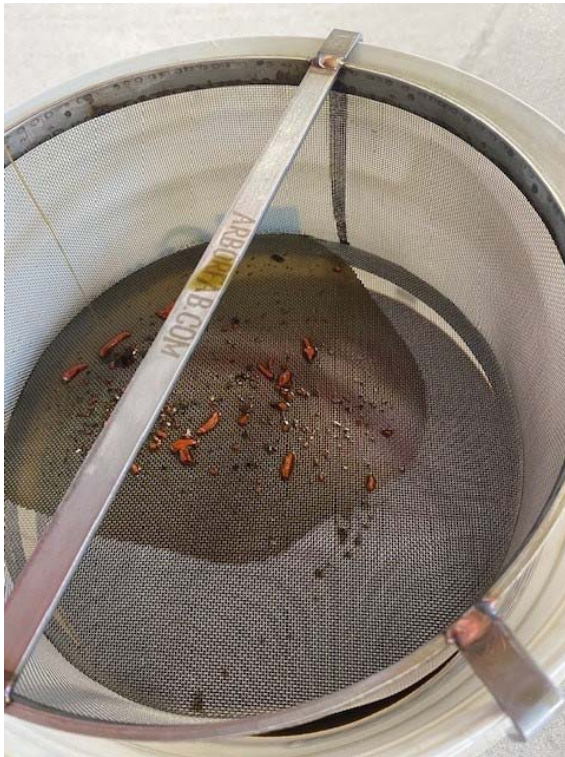
Oil was Drained into Screen to Reveal Metal and Elastomer Pieces

Metal and Elastomer Pieces in Oil Screen

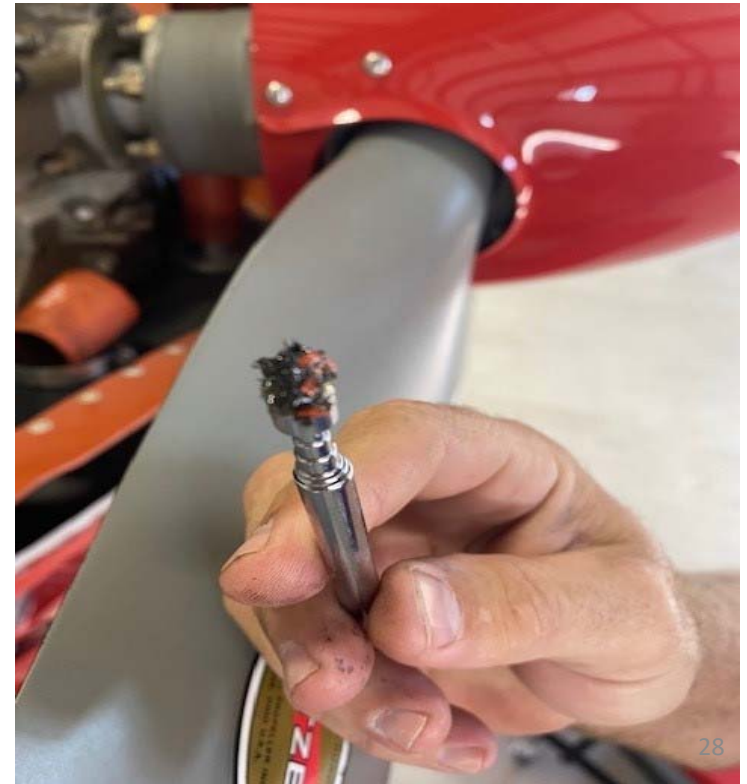
Metal Pieces from Oil Attracted to Magnet

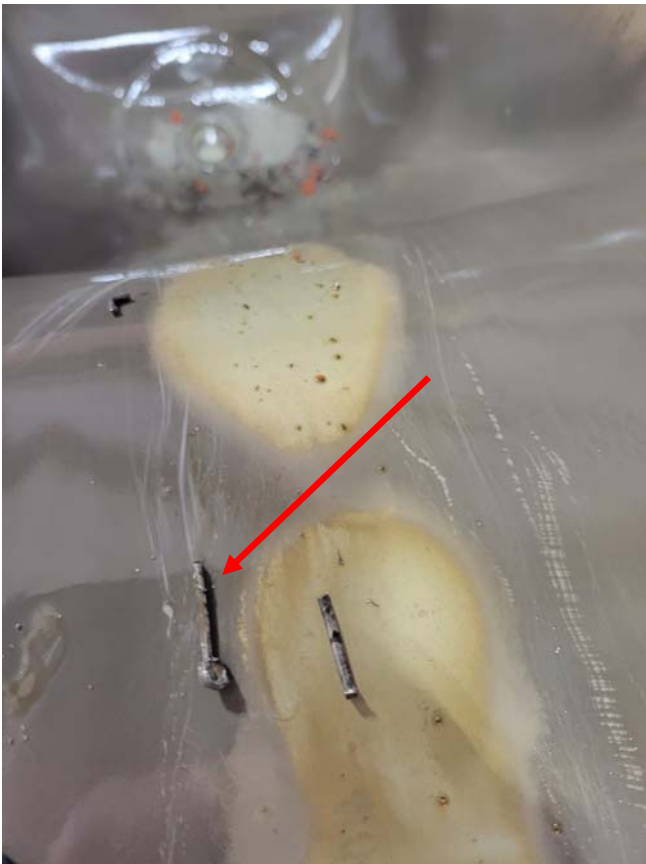
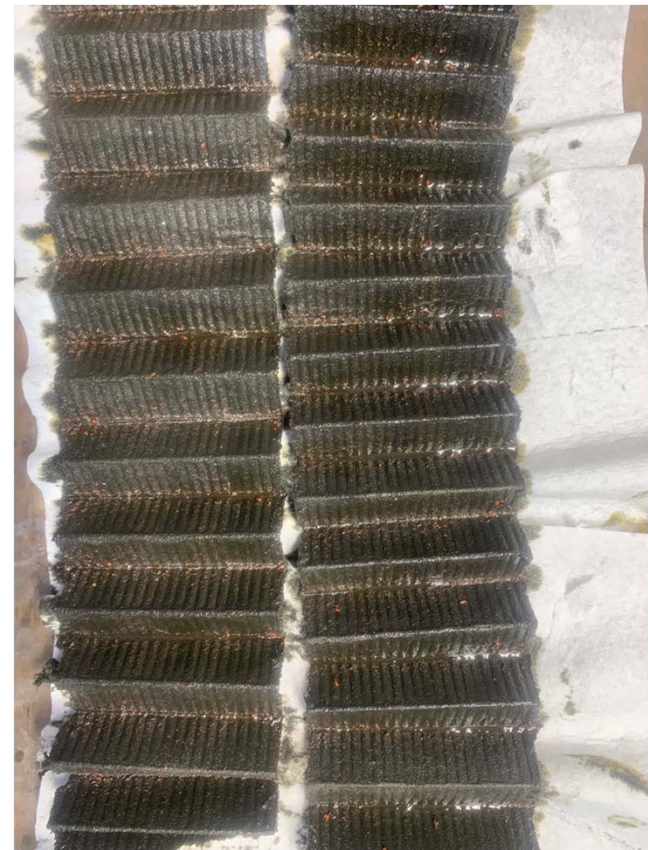
Cotter Pin Found in Crankcase and Metal in Oil Filter
