Loss of Electrical System over the Rocky Mountains: And that was the Good News!

17 January, 2024
VASI Meeting, Venice, FL

Jack Henion

Engine and Equipment Status for N5379A

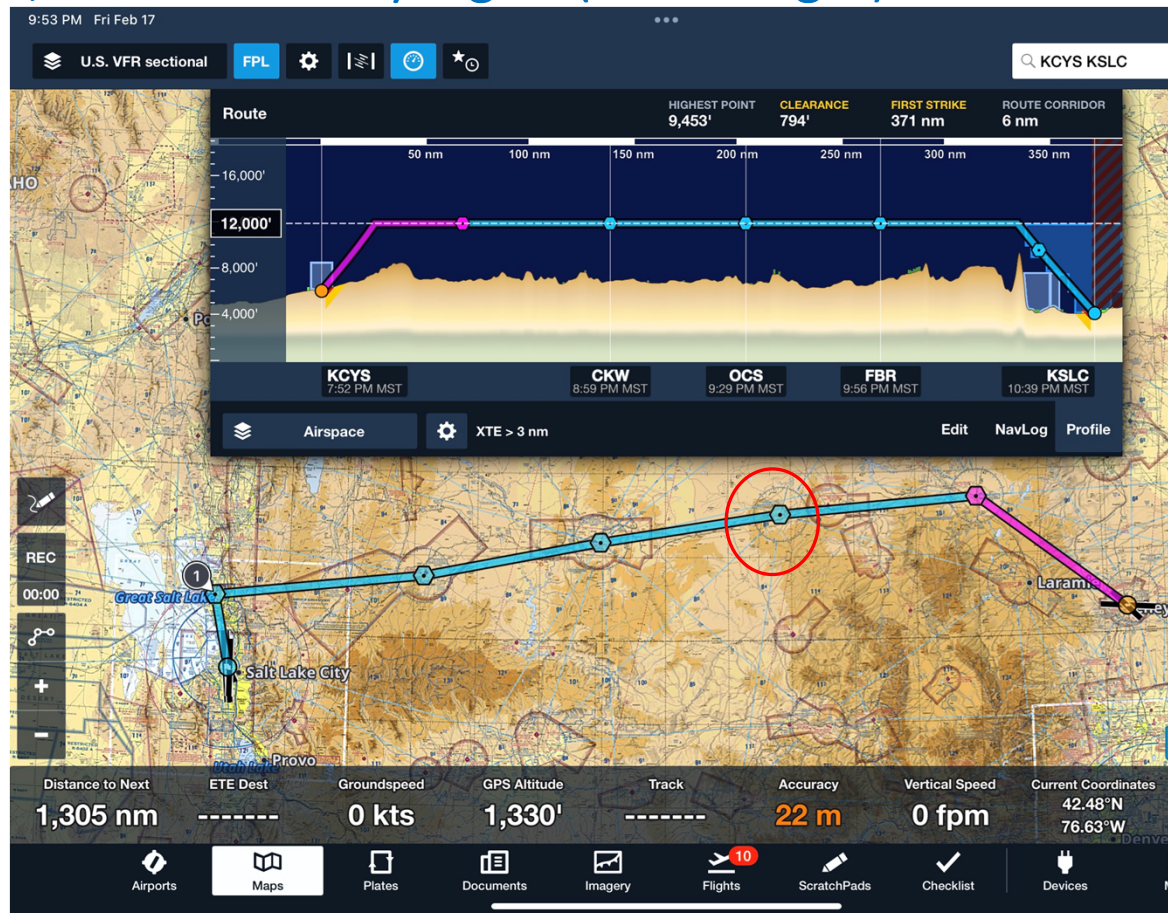
After reaching 12,000 ft I suddenly saw this and major discharge on the JPI 930 EDM alternator meter

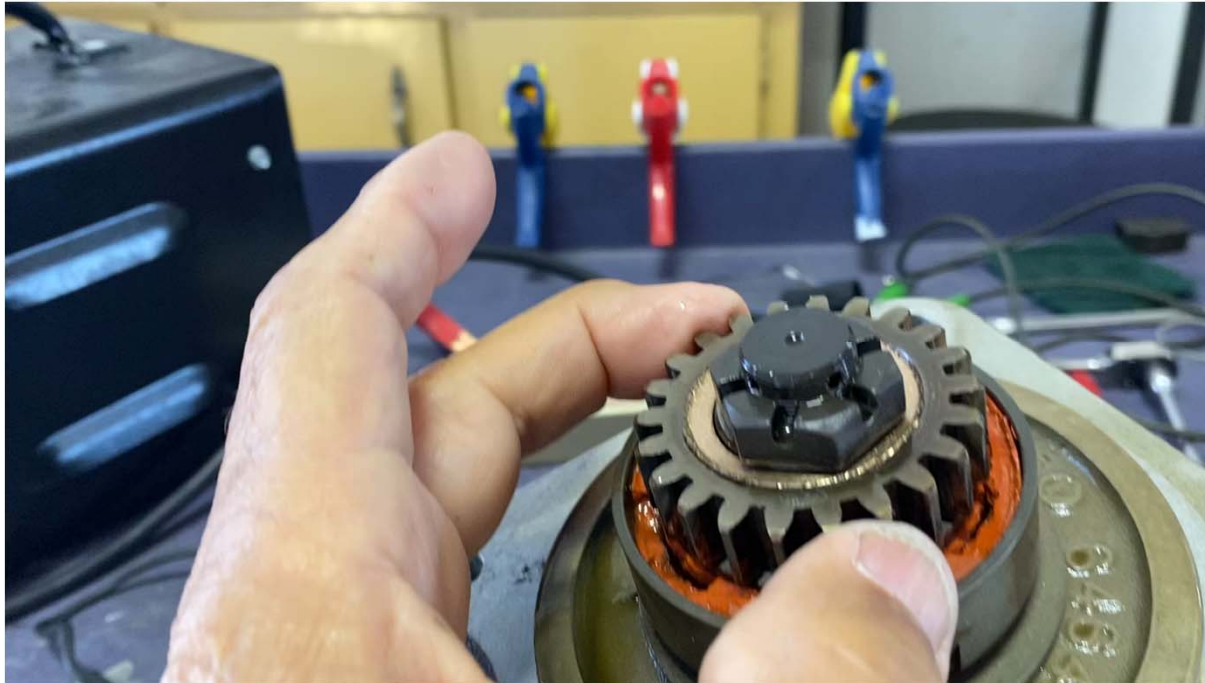
IO 550 Direct Drive Alternator Gear

Noticed the Alternator Drive Gear was missing its Cotter pin and was Loose!

No Cotter Pin

Four Loose bolts on Crankshaft Face Gear!

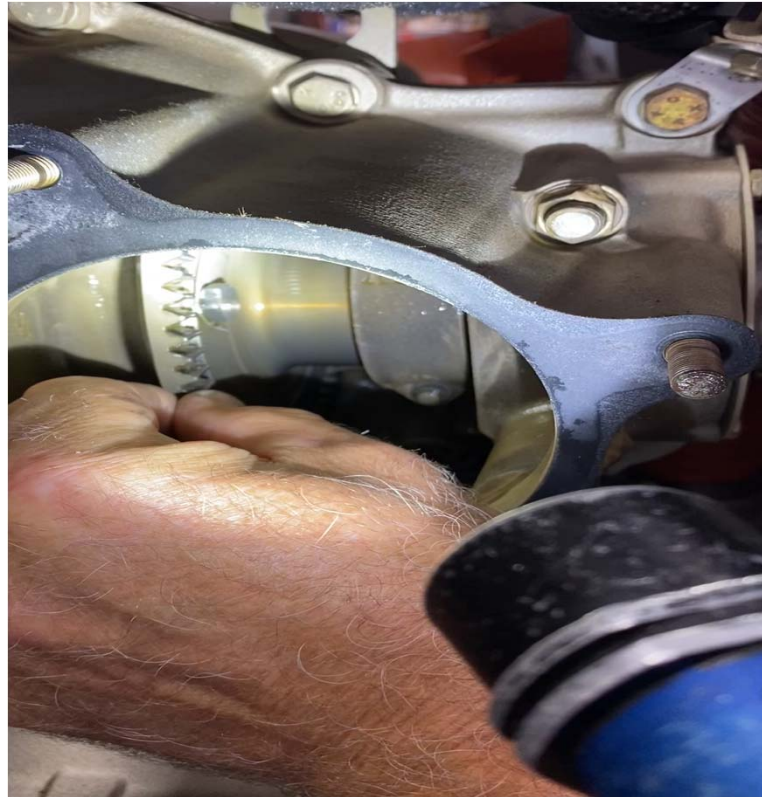
IO 550 Crankshaft Face Gear

Damage to Face Gear Teeth

Damaged Face Gear Removed from Crankshaft

Crack in two of the Threaded Bolt Holes

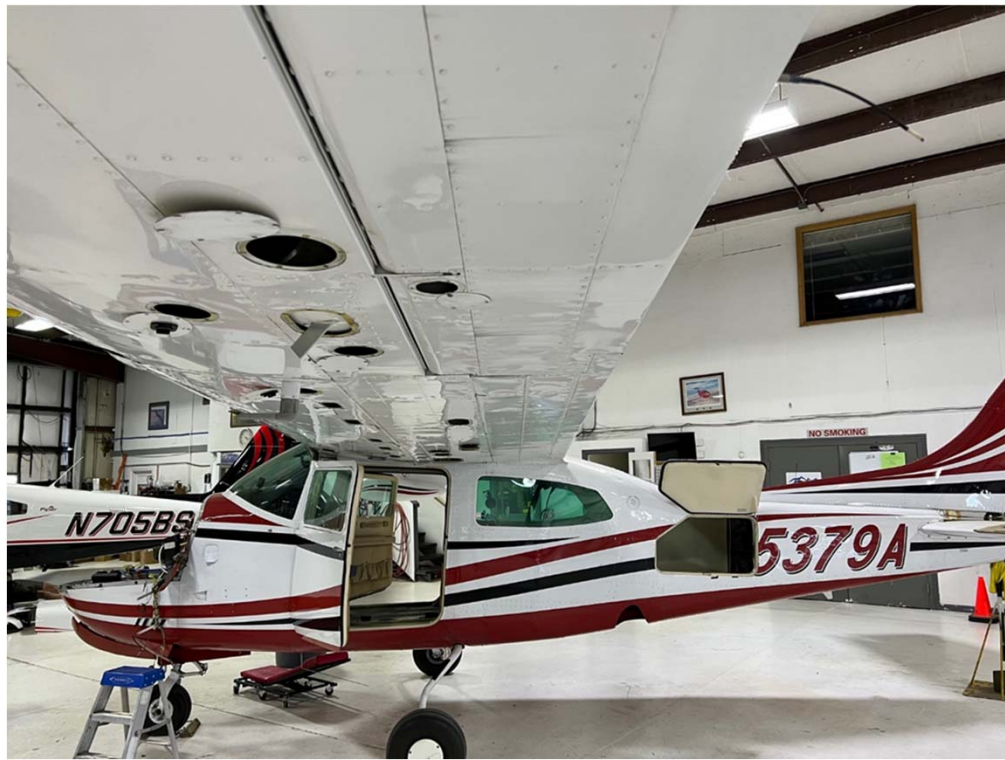
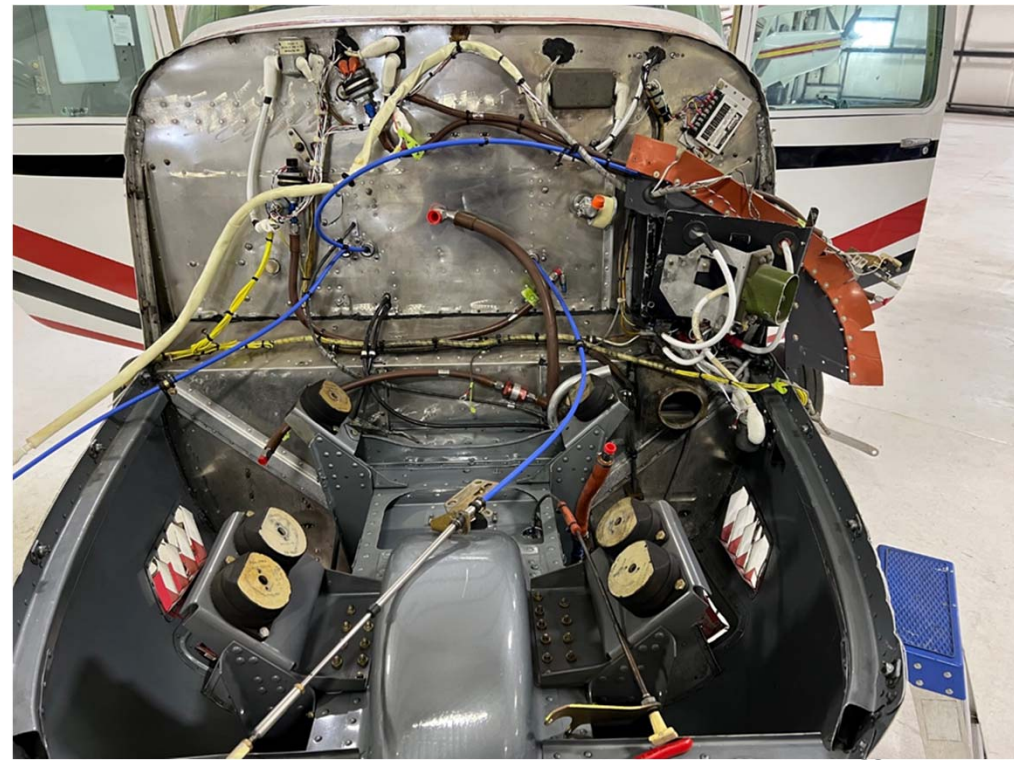
Engine was removed and delivered nearby to 'The New Firewall Forward Shop' to 'Repair' it

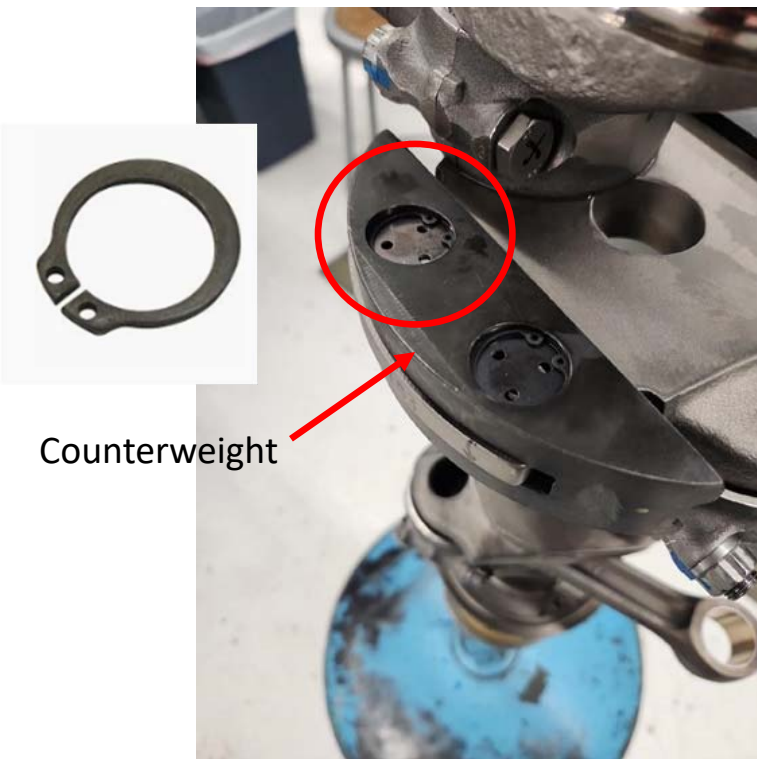
What is a Retaining Ring? (sometimes called a 'Circlip)

- Docket No. FAA-2023-0172; Project Identifier AD-2023-00265-E; Amendment 39-22355; AD 2023-04-08
- RIN 2120-AA64
- This AD and final rule is effective February 23, 2023 and affects **any crankshaft assembly on a Continental Engine**. Due to improper installation of the counterweight retaining rings during manufacture loosening of a counterweight retaining ring may result in the loss of retention of the counterweight. If not addressed, the condition could result in catastrophic engine damage and possible engine seizure.
- An inspection of the crankshaft is required prior to further flight or a ferry permit must be obtain to fly the aircraft to a place where the inspection can be performed.

- The New Firewall Forward shop that ‘repaired’ my IO 550 engine provided written documentation which was entered into my engine logbook that they properly installed the crankshaft counter weights
 - Whew! My AD is satisfied
 - Was this whole alternator incident a blessing in disguise?

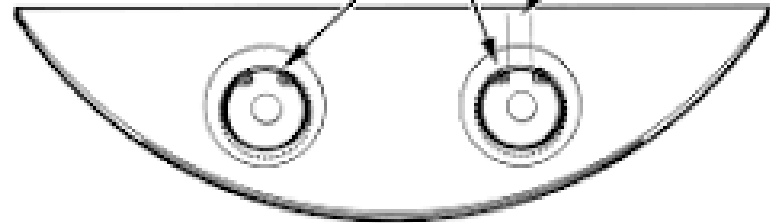
INSTALL RETAINING RING EARS TOWARD THE CRANKSHAFT CENTERLINE AS SHOWN

MINIMUM GAP BETWEEN RETAINING RING EARS - 0.212 INCH
